Advances in the application of **Ultraviolet** light for swimming pool disinfection.

Tony Leigh , atg UV Technology

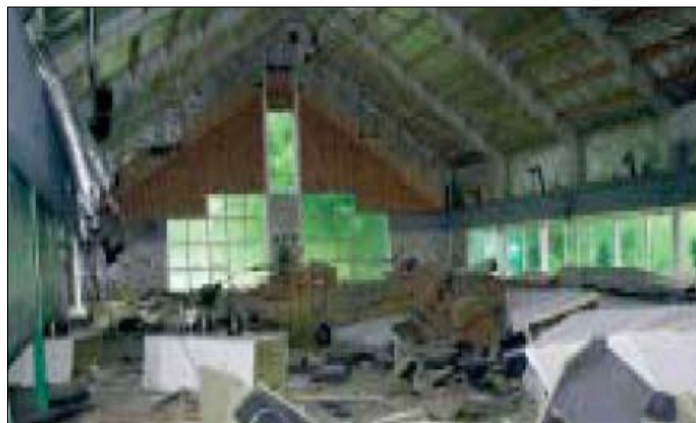
Collapsed pool ceiling in Holland caused by stress corrosion cracking.

Other effects of chloramines can include corrosion of the pool structure. The volatile chloramines carry chlorine species to condensation in parts of the building remote from the pool. Repeated evaporation causes these species to concentrate, causing both safety critical damage and area degradation. Stress corrosion cracking of roof supports, wire suspensions and bolt heads can lead to catastrophic failure. Pool ceilings collapsed at Steenwijk (Netherlands) in 2001, and in Uster (Switzerland) in 1985.

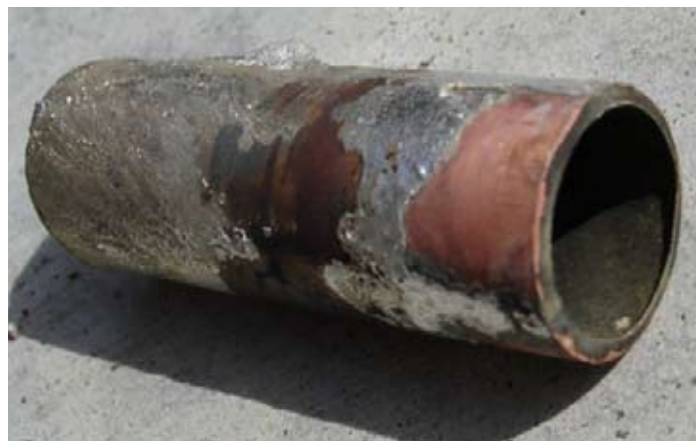
Copper pipe pin holes caused by a switch to chloramines Photo Marc Edwards, Virginia Tech.

Chloramines are linked to pin hole failure of copper pipe, however the phenomena is site specific

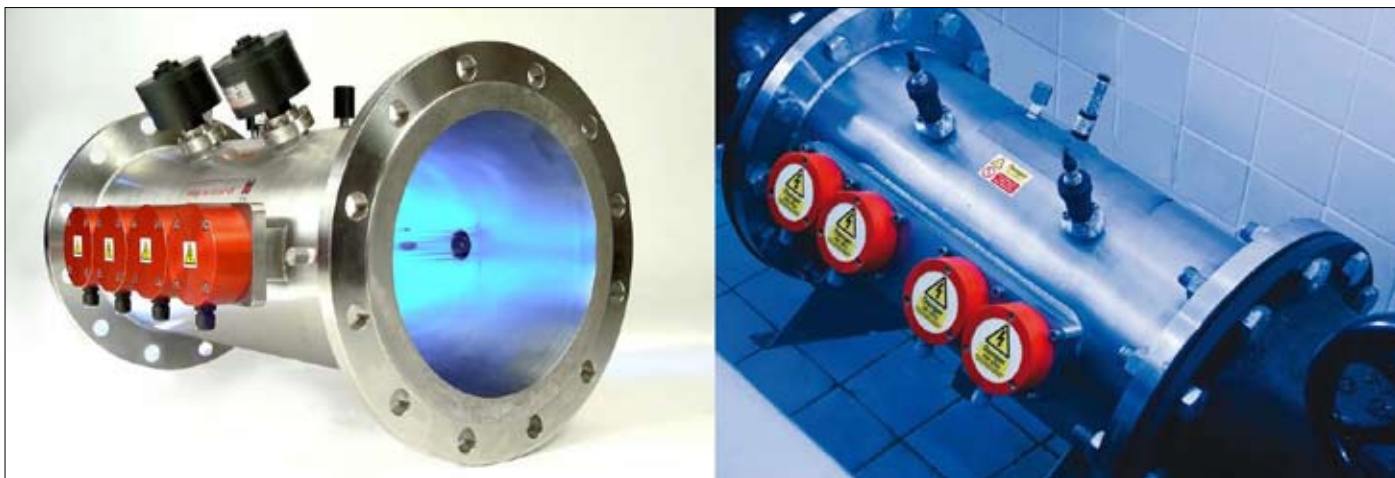
UV system undergoing performance validation for use in New York State.

System sizing is a function of determining three variables; flow rate, what organisms are likely and the transmittance of the water. Several factors can effect the transmittance of the water, including turbidity, suspended solids and color. Variations in these parameters are undesirable for recreational water. Several UV companies have undertaken system validation using non pathogenic surrogates such as MS-2 phage to verify actual performance using a third party test house, and to properly understand the capacity of the machines. New York state requires that all UV systems are independently validated in accordance with strict protocols.

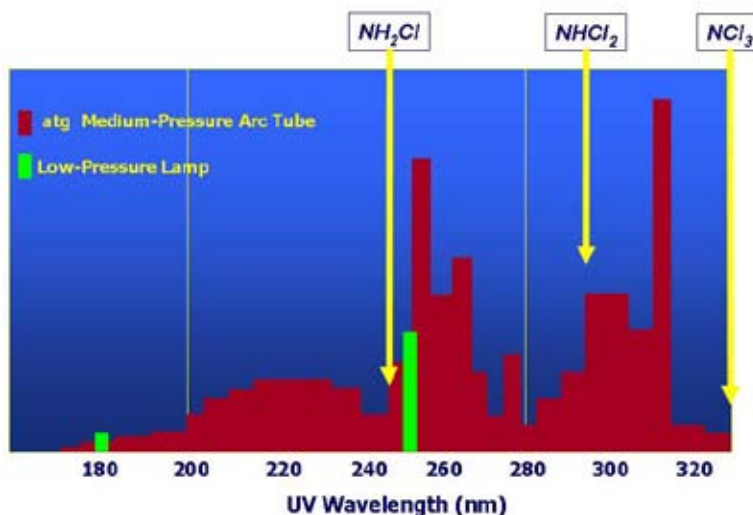
Monochloramine (NH_2Cl) species absorb UV light at 245nm. Dichloramine ($NHCl_2$) species absorb UV light at 297nm, and Trichloramine (NCl_3) species absorb UV light at 340nm.

Medium pressure (polychromatic) lamps produce these wavelengths in abundance, however as low pressure lamps only produce a single UV line at 254nm, they are not well suited to use for the specific removal of the nuisance chloramine species.

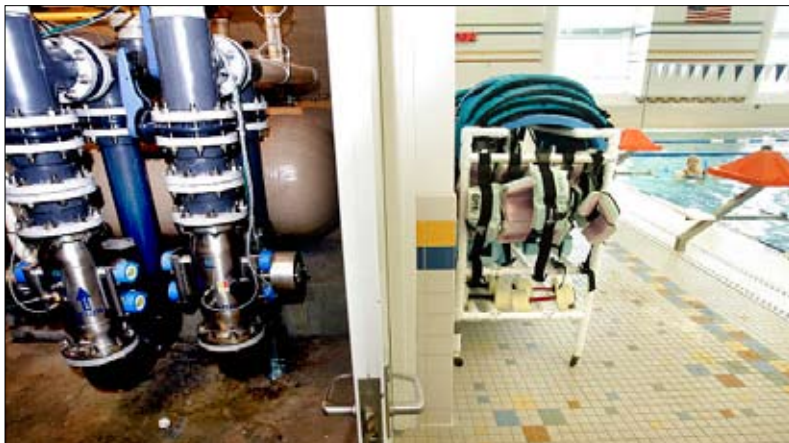
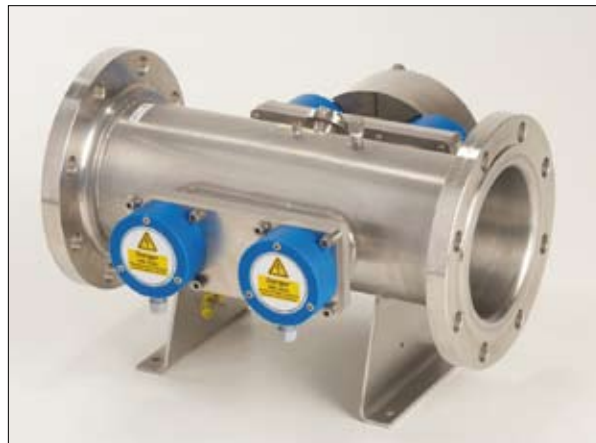
ETS chambers installed at Utah Pool

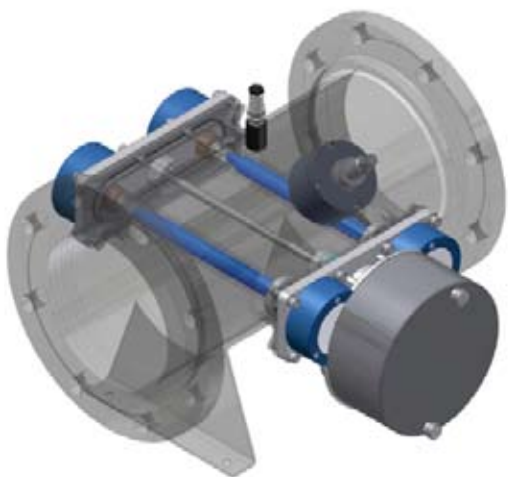
CAD drawing of wiper (ETS)

The UV lamp is contained within a quartz sleeve, and the sleeve will be fouled by iron in the water being treated. UV light will accelerate the photochemical deposition of iron onto the surface of the quartz, and will quickly occlude the optical path unless it is removed. Automated wipers are fitted to most pool systems to remove fouling from the surface of the quartz. Early system design used limit switches and magnets to locate the position of the wiper assembly, however their complexity led to them being replaced with more reliable embedded pulse technology.

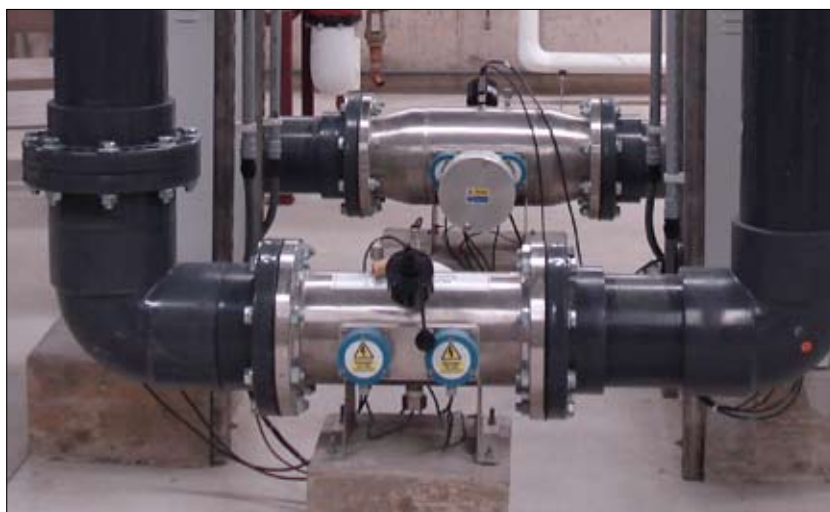
ETS chambers installed vertically in pool filter room
